Induction Lighting Case Study: Retail Store Lighting

By: InduLux Technologies

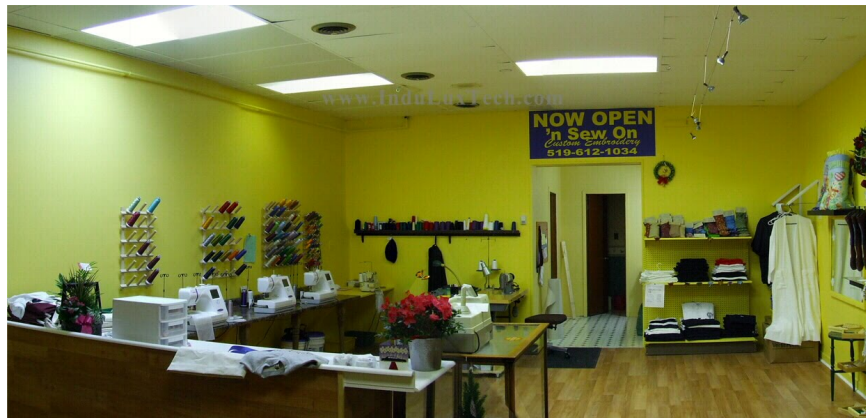
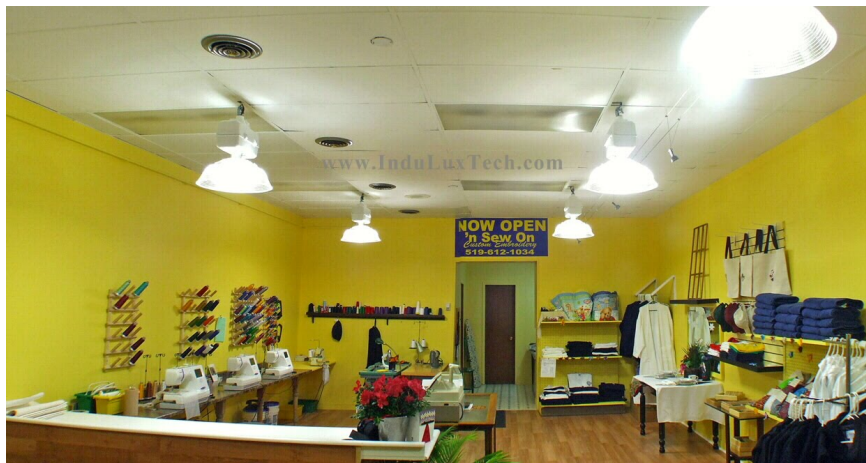
TOP: Retail store before upgrading to Induction Lighting
BOTTOM: Magnetic Induction fixtures installed in the retail store

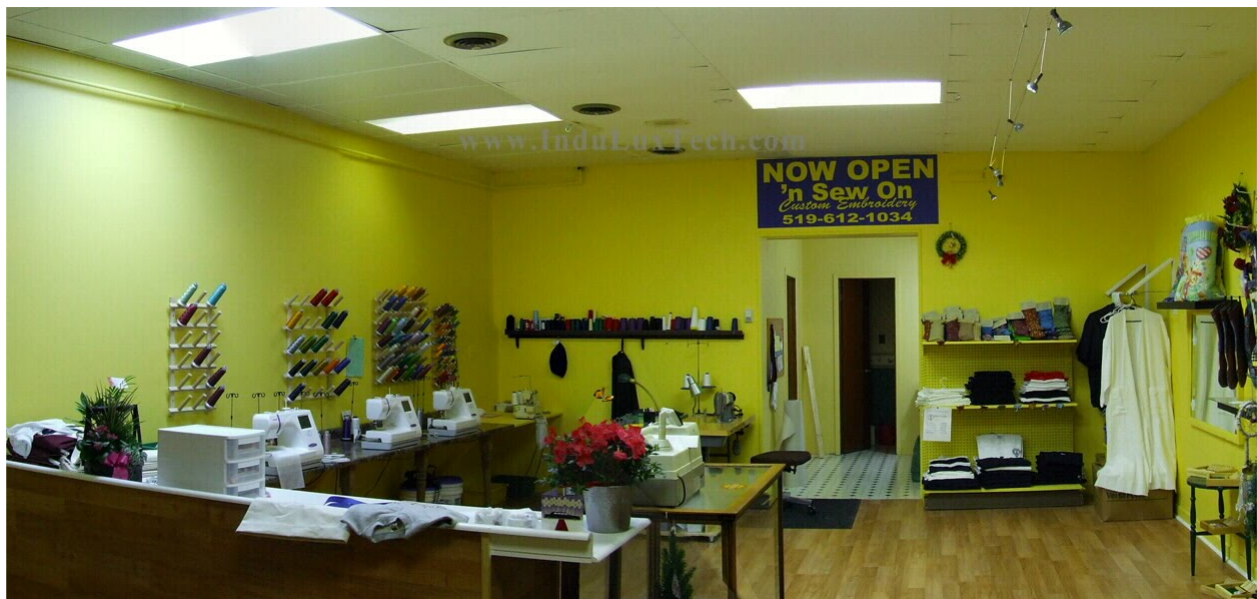
The type of work being done relies on fine vision for dealing with small stitching. Colour rendering is an important issue when matching the colours of embroidered corporate logos. The store had only been open for a few weeks and already the owner and staff of the store complained that the lighting was not bright enough over the embroidery machines and was also uneven - especially in the far corners of the store (see photo below).

BEFORE: The retail store lit with 4-tube florescent troffer fixtures. Note the uneven light distribution, with the far left corner of the store, where three sewing machines were located, being particularly dim.

The main store area was originally lit by means of five 2 X 4 suspended ceiling “troffer” type fixtures each using four 40W fluorescent tubes with dual “coil and core” type ballasts. In addition, there was a suspended wire track-lighting system using eight 20W, MR16, halogen incandescent lamps for spotlighting merchandise on shelves and wall display boards.

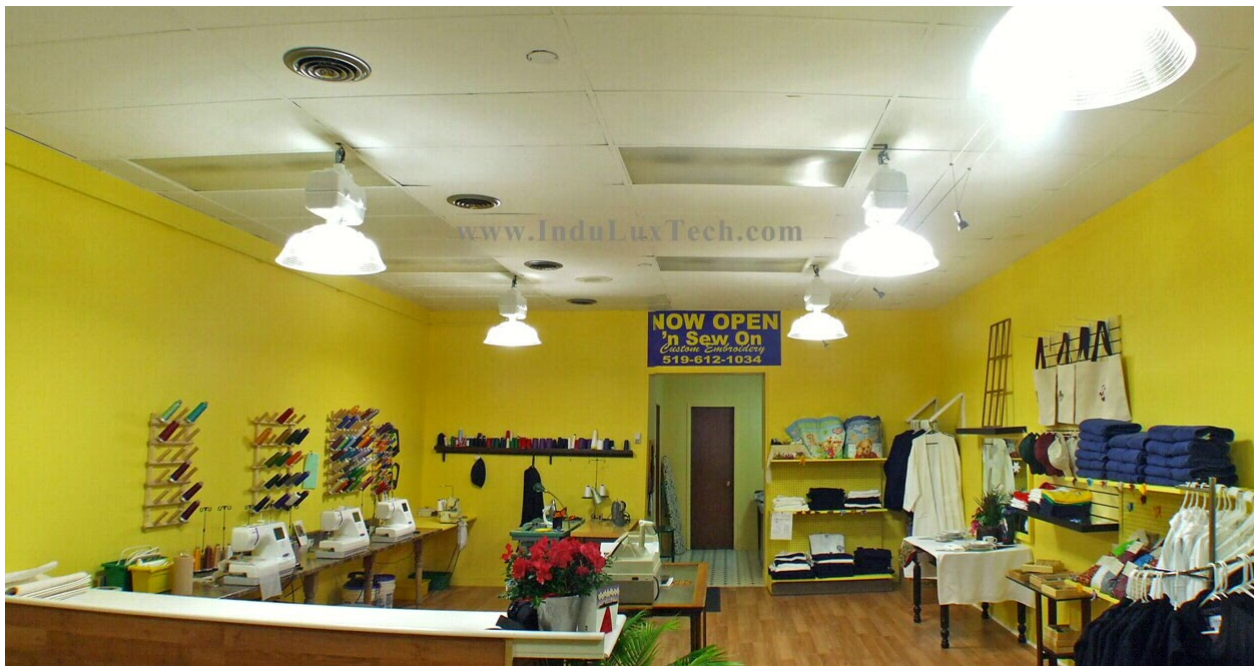
AFTER the upgrade: A view of the store where 5 of the induction low-bay fixtures are visible. Note that the light distribution is now more even and the space is much brighter.

As can be noted from the diagram (above) and seen in the “after” photo (top of next page), the work areas are now more uniformly lit and all of the work stations are at, or above, the recommended 500 Lux for fine work.
